All Jersey Entp. LLC
1930 Selene Ave
South Plainfield, NJ 07080
Tel: 908-917-0194 Fax: 908-412-6527

Visual Property Inspection

21 Mare Haven Ct.
North Plainfield, NJ 08902

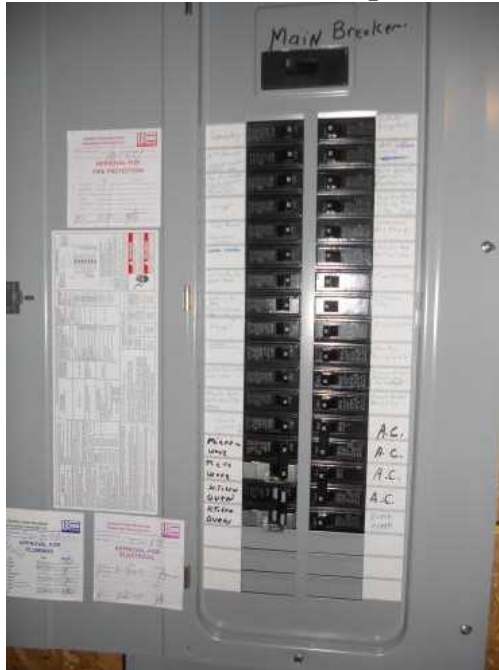
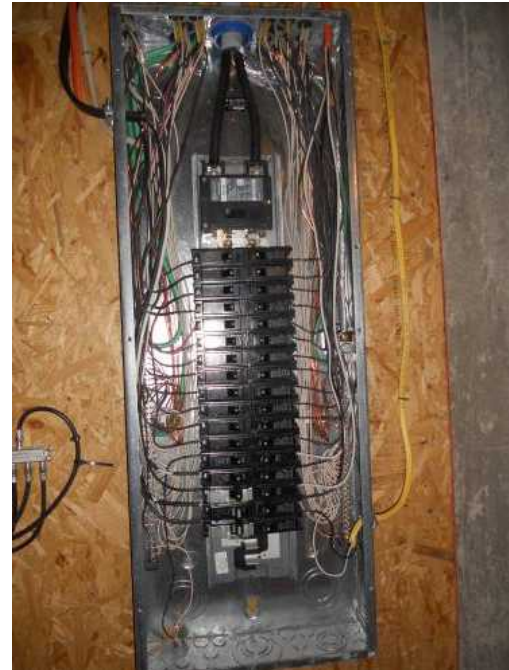
Basement Electric Panel

Maximum Capacity: 200 Amps

Main Breaker Size: 200 Amps

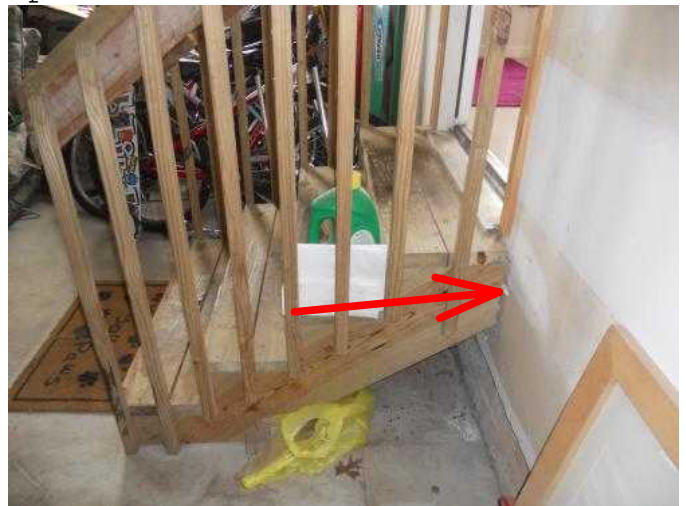
Repair or Replace Stairs/Handrails: Wood stairs with wood handrails
The wood stair stringer in the garage is improperly fastened to the wall. The stairs needs be fastened to the wall more securely with joist hangers.

Stairs/Handrails: Wood stairs with wood handrails The wood stair stringer in the garage is improperly fastened to the wall. The stairs needs be fastened to the wall more securely with joist hangers.

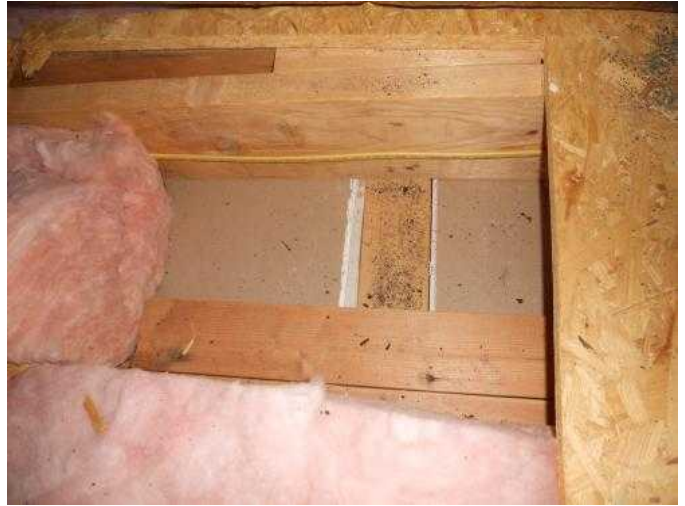
Repair or Replace **Insulation:** Batts **A section of the attic was missing insulation. Additional insulation is required in this area.**

Main Attic Insulation: Batts A section of the attic was missing insulation. Additional insulation is required in this area.

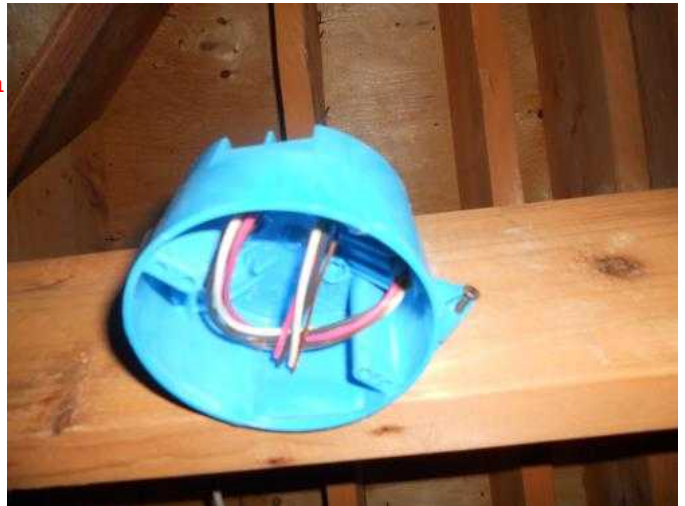
Repair or Replace **Wiring/Lighting:** 120 volt lighting circuit **Junction box has exposed live wires. A junction box cover is required.**

Main Attic Wiring/Lighting: 120 volt lighting circuit Junction box has exposed live wires. A junction box cover is required.

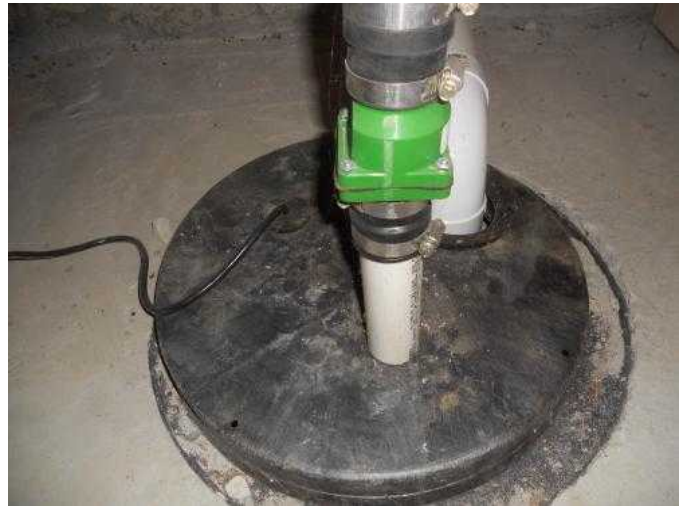
Sump Pump: Submerged Recommend the addition of a back up battery to ensure continued operation during a power outage.

Main Basement Sump Pump: Submerged Recommend the addition of a back up battery to ensure continued operation during a power outage.

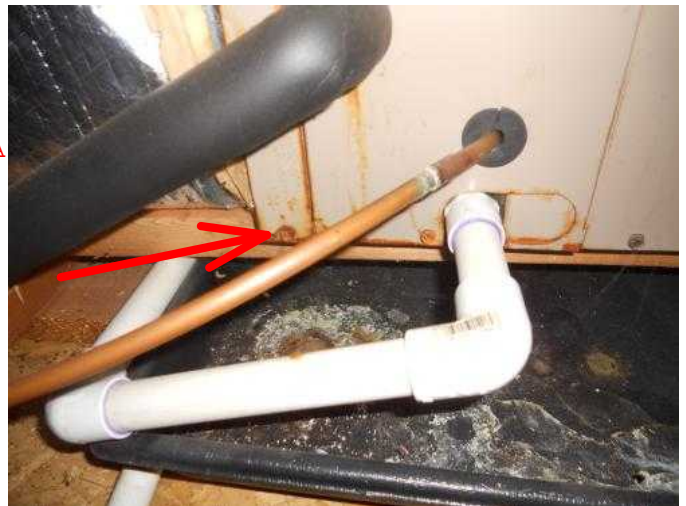
The unit located in the attic is showing signs of leakage. A qualified contractor is required to further evaluate and estimate repairs.

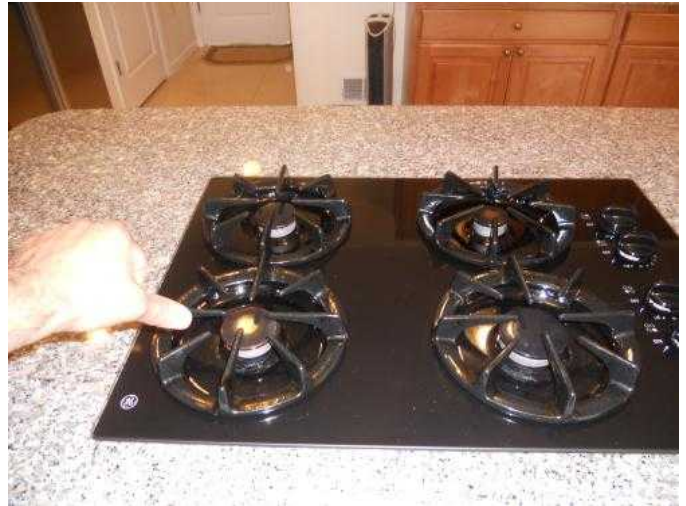
Repair or Replace **Cooking Appliances:** Gas range **The front left burner was inoperative, and requires repair.**

Main Kitchen Cooking Appliances: Gas range The front left burner was inoperative, and requires repair.
